Church Rock Uranium Monitoring Project

Larry J. King
Resident, Churchrock Chapter,
Navajo Nation, New Mexico

**USEPA Community Involvement
Conference, June 2007**

Church Rock
Uranium
Monitoring
Project,
2003-2007

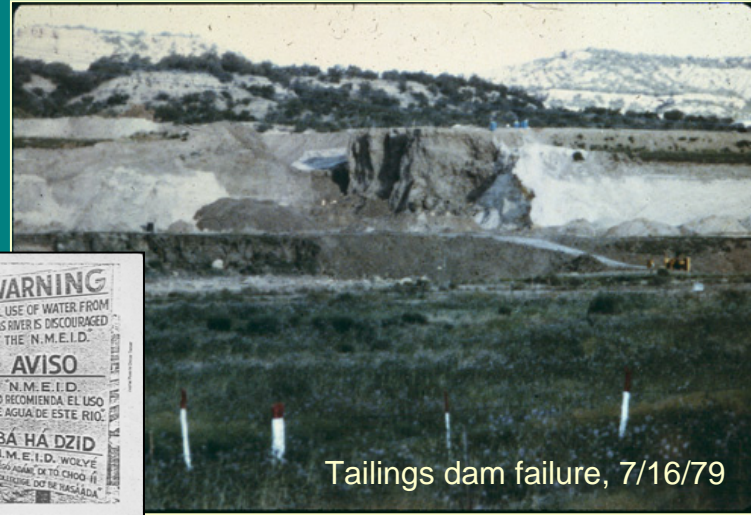
Tailings dam failure, 7/16/79

- Active mining, early-'50s thru mid-'80s
- 19 abandoned mines, 1 closed uranium mill in area (see map, next slide)
- '79 tailings dam failure — U.S.'s largest release, by volume, of radioactive waste
- Mine dewatering for 20 years
- Livestock studies of '80s —
 - uptake of radionuclides in muscle, organs of sheep, cattle
- Little environmental monitoring since
- **No health studies ever conducted**
- New ISL mining proposed in Churchrock, Crownpoint chapters

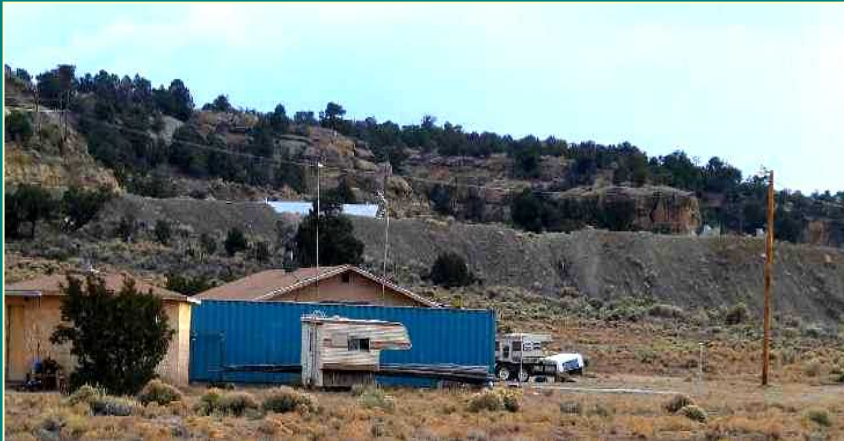
Navajo home next to uranium mine waste dump, 2005

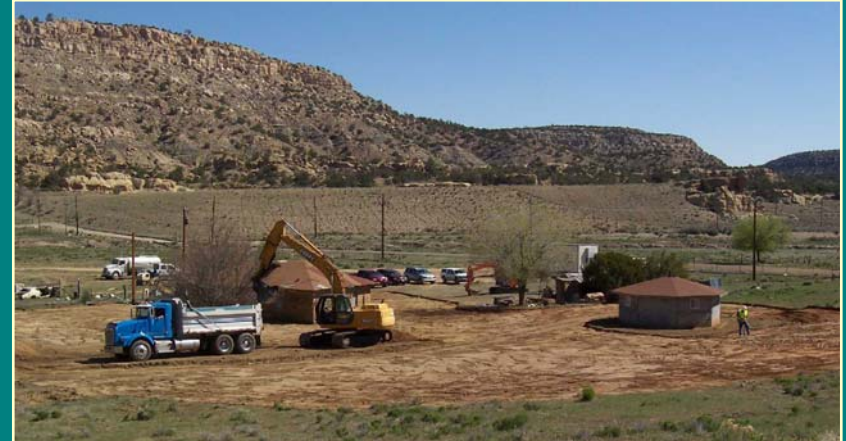
Radium-contaminated soil removal, Red Water Pond Road, 2007; partially reclaimed abandoned mine in rear

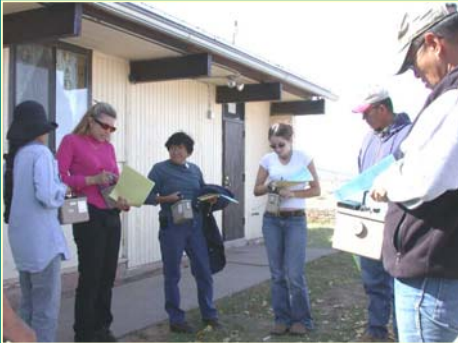
- 20+ people from Churchrock, Navajo Nation, SRIC, TAMS Center, USEPA participated in surface gamma surveys
 - community members trained in instrument calibration, field use, data transcription (left)

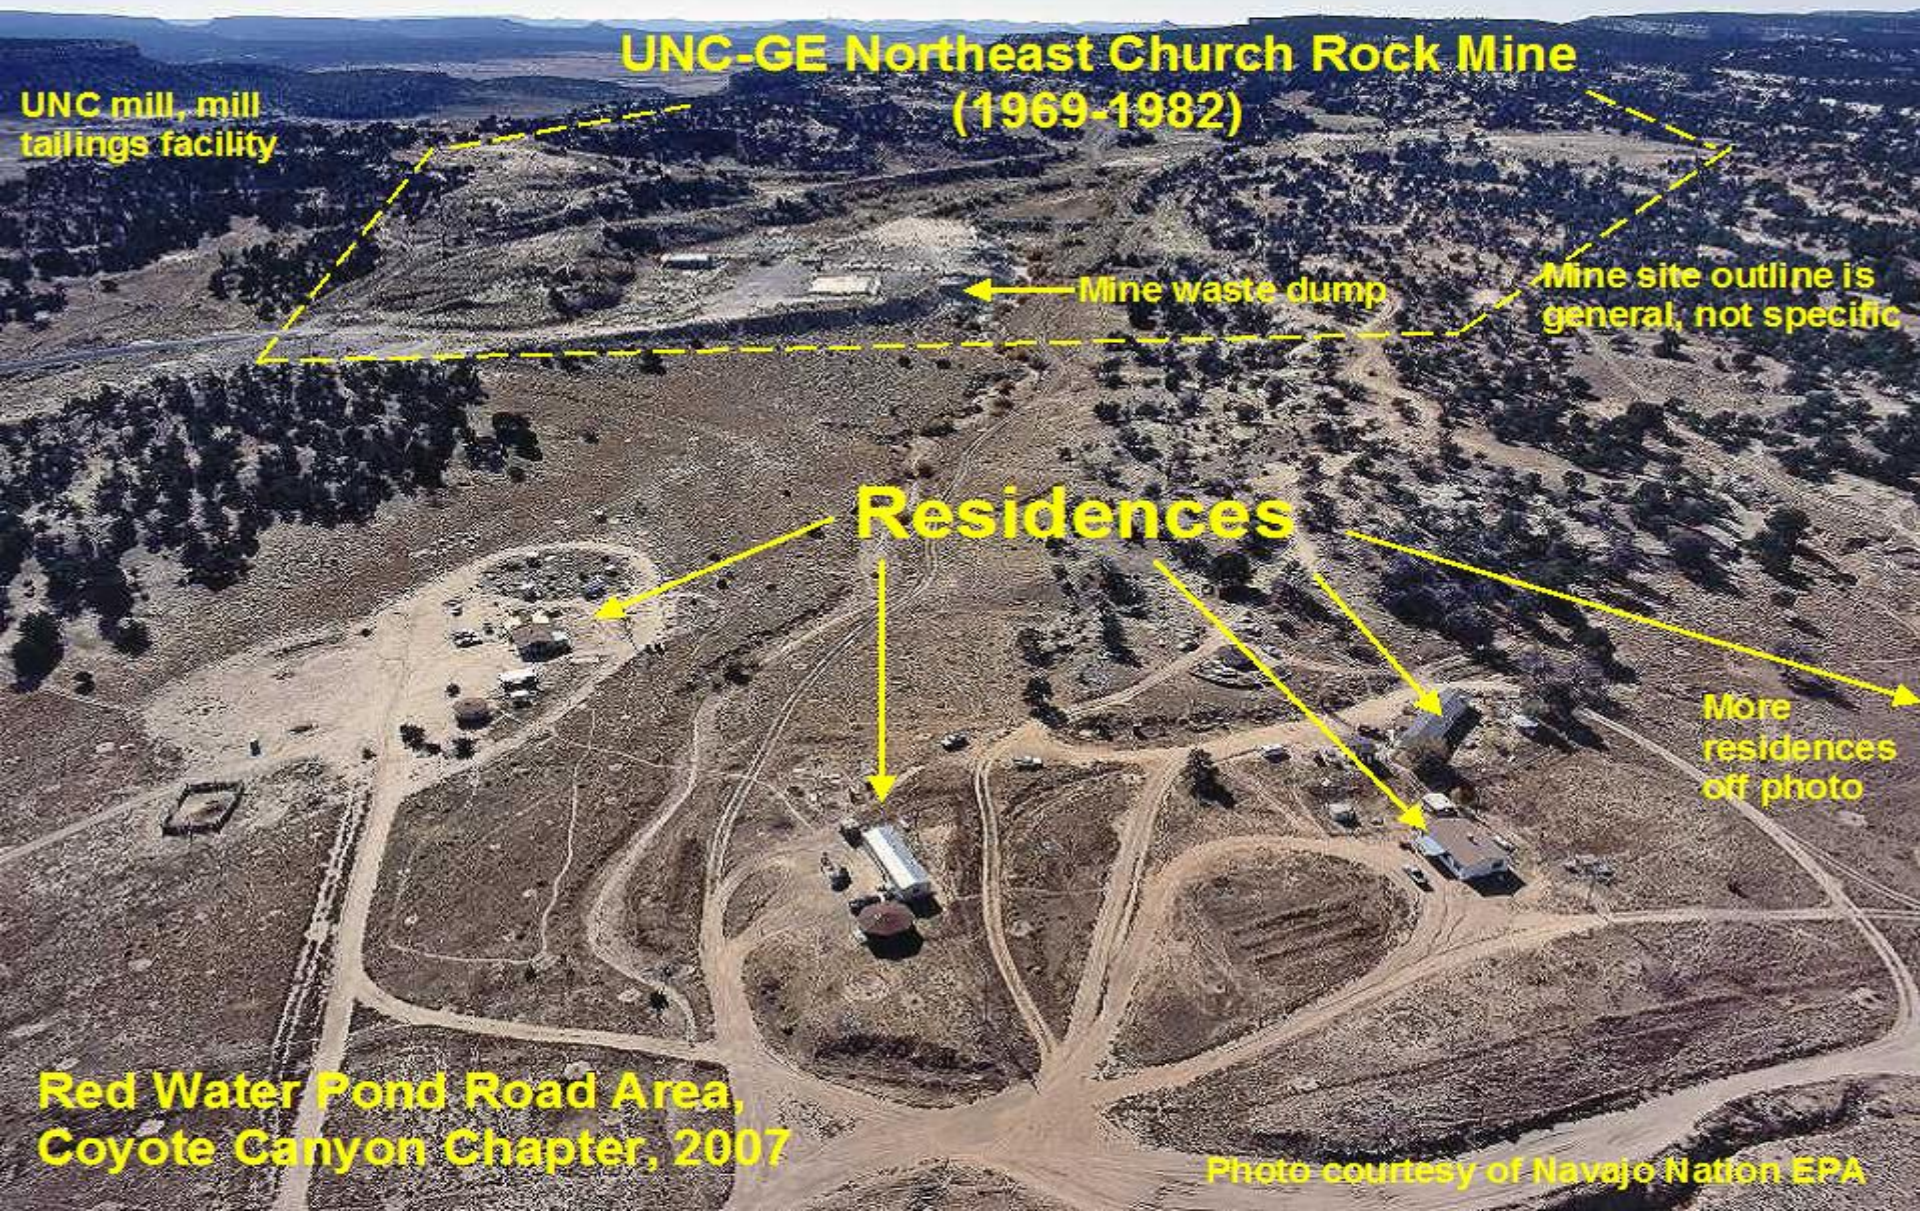
**Red Water Pond Road Area,
Coyote Canyon Chapter, 2007**

**UNC-GE Northeast Church Rock Mine
(1969-1982)**

**UNC mill, mill
tailings facility**

Mine waste dump

Residences

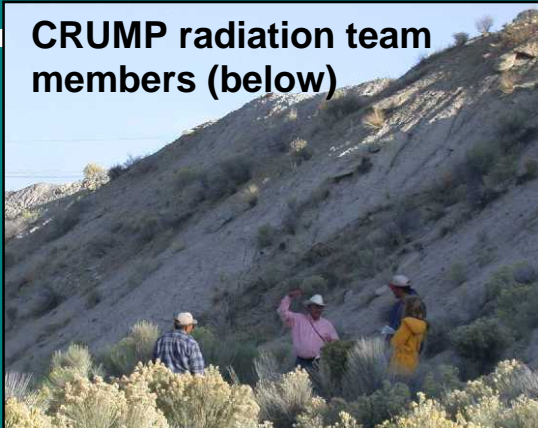
Gamma radiation
levels at the base of
mine-waste pile
ranged up to 20x
background at the
Reservation line;
soils contained
elevated U

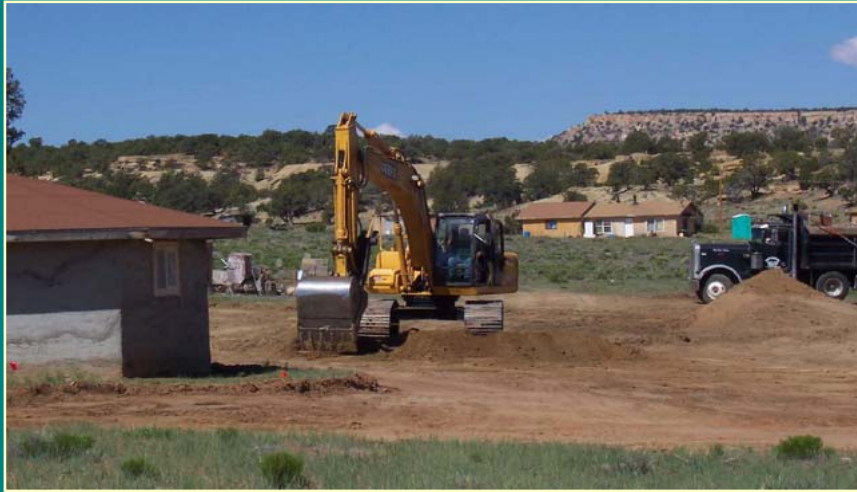
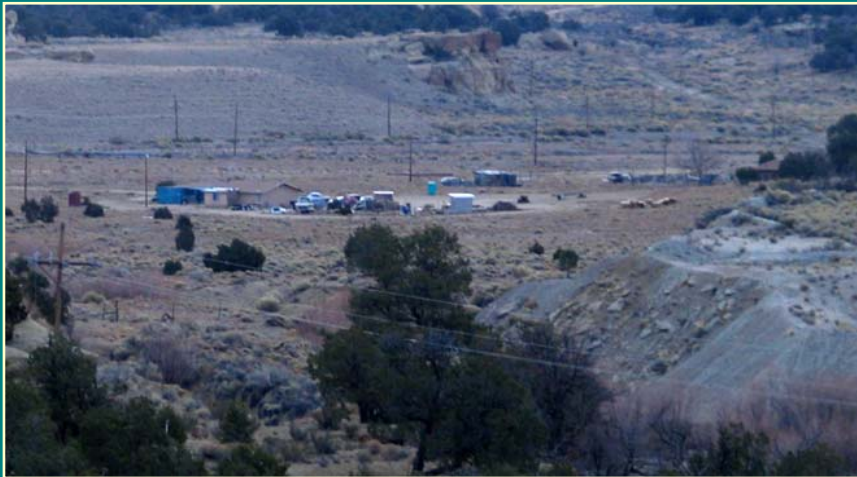
- CRUMP gamma surveys, uranium-in-soil studies prompted responses by USEPA, NNEPA
- May 2007: USEPA removed nearly 6,000 cubic yards of radium-contaminated soils from around residences (upper left)
 - Soil removal may not be sufficient for long-term protection of public health
- 2007-2009: Reclamation of NECR mine site (lower left)
 - Goal of community, Navajo Nation is complete removal of mine wastes from tribal trust land

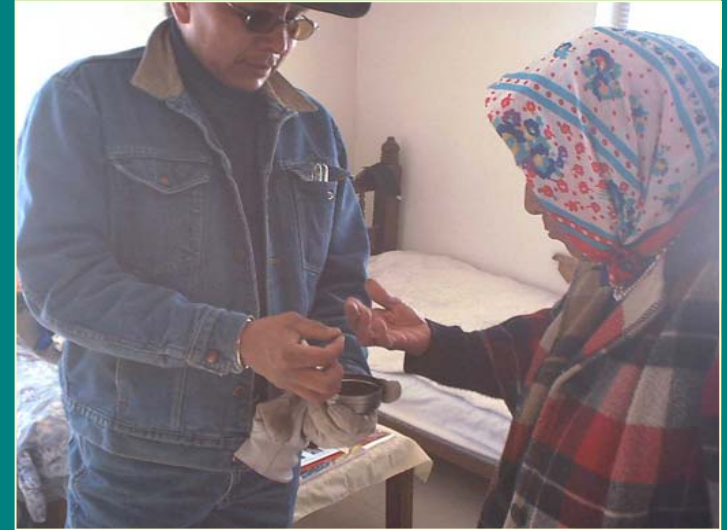
John Plummer, NNEPA Radon Program, shows Pipeline Road resident the charcoal inside a radon canister

- ◆ 7-day radon canisters placed in 150 homes in Feb.-March '04; valid results from 143 homes
 - ◆ 36 homes (~25%) had Rn levels greater than the USEPA “action level” of 4 pCi/l air
 - ◆ Action level carries lifetime lung cancer risk equivalent to smoking 1-2 packs of cigarettes per day
 - ◆ 29 homes (~20%) had Rn 2-4 pCi/l
- ◆ Estimated 80% of homes with high Rn located on outcrop of uranium-bearing rock formation
- ◆ Mitigation measures shared with residents; retests anticipated in 2007

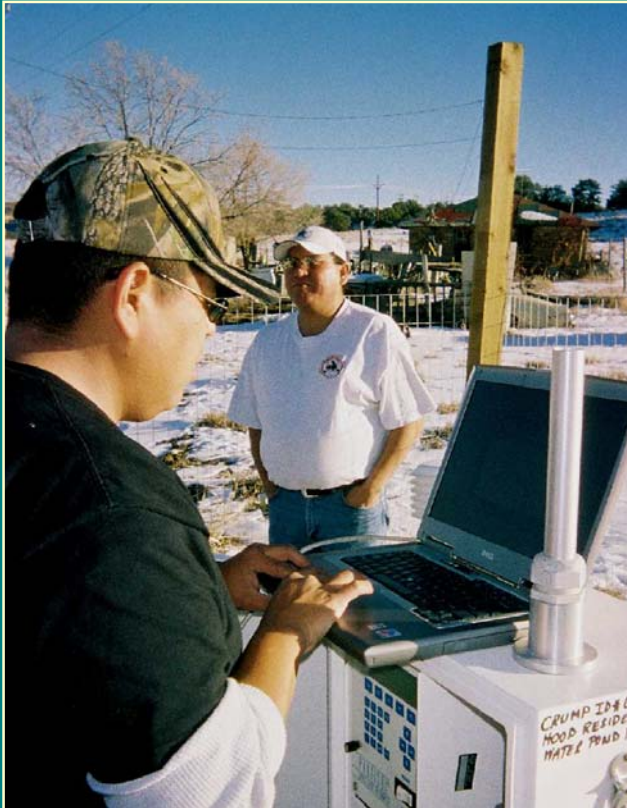
- Monitoring began May 2006
- Two sites: Red Water Pond Road, Pipeline Canyon Road close to residences, abandoned mines
- Compare dust levels with federal particulate limits
 - Thru Feb. 2007, highest 24-hr concentration was 15% of national air quality standard for particulate matter
- Requesting USEPA-LV lab analyze 10% of filters for radionuclides
- Develop, validate predictive model of inhalation exposure
